High Level Sewershed

Run Summary —								
Test ID	Test Type	Date Inspected	Company / Super.	Blower MH	Ground Condition	Notification Made?	Total Length	
S1028-126	Smoke	10/20/2008	ADS/TM	S13II_032MH	Dry	Yes	901.03

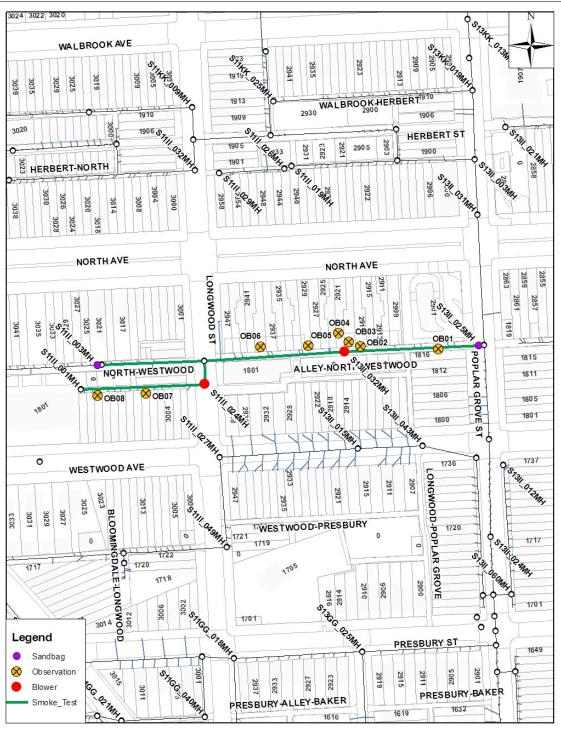
Isolated Pipes Length Diameter Pipe ID **Upstream MH Downstream MH** (ft) (In) S13II_032G1 S13II_032MH S13II_025MH 249.7878 8 S11II_024G1 S11II_024MH S11II_030MH 42.39579 8 S11II_030G1 S11II_030MH S13II_032MH 251.7740 8 S11II_001G1 S11II_001MH S11II_042MH 173.6184 8 S11II_003G1 S11II_003MH S11II_030MH 183.4506 8
